Survey on Microplastic Leakage in the Mekong River Basin

1. Summary

This study reports the results of the survey on the leakage of microplastic and such in Vientiane (Lao PDR), Phnom Penh (Cambodia), and Can Tho (Vietnam) in the Mekong Basin, from January to March 2020, aiming to elucidate the actual situation of plastic leakage.

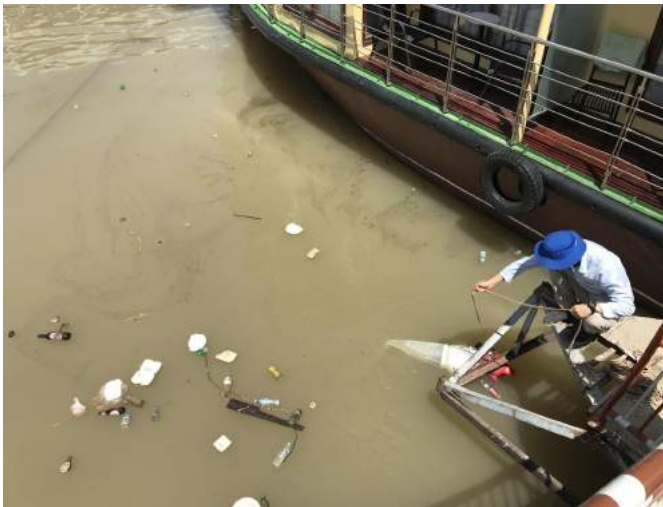
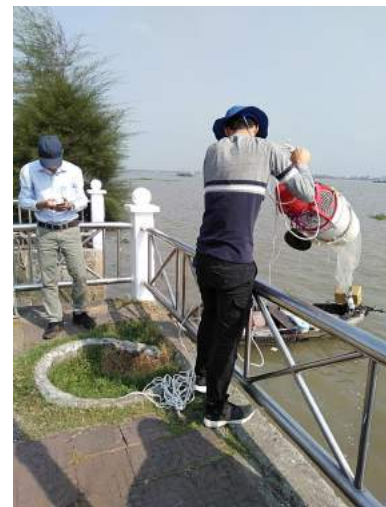
Using a battery-driven propeller to pass surface-level water through a net, we developed a specialized sample collecting device with all the required functions; the Albatross Mark V lite. Water at each survey point was filtered by the net and solid particles were collected.

Figure 8,9 Collecting solids with the device (Albatross Mark V lite)

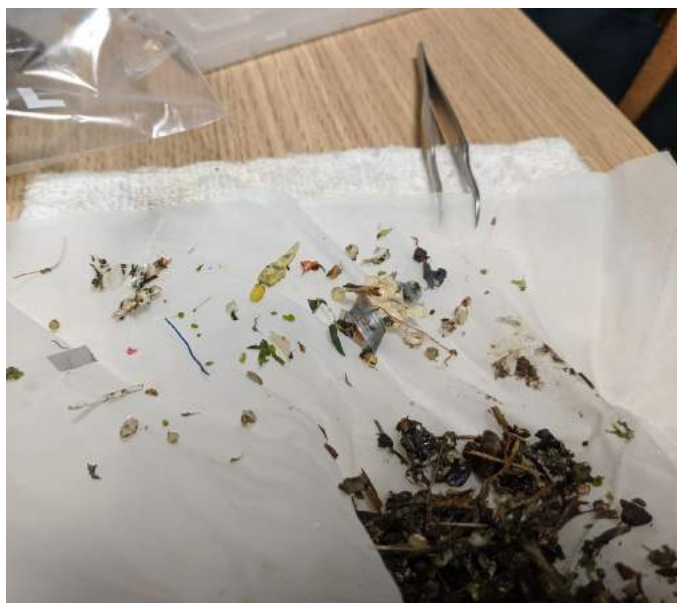
In this process, particles that seemed to be plastic were extracted from the collected solids for analysis. In this study, particles that seemed to be plastic were extracted using tweezers following a visual inspection.

Figure 10 Extraction in progress

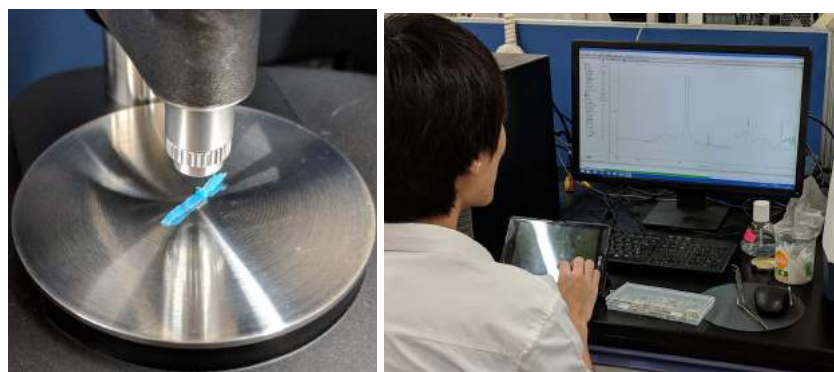
In this process, the extracted solids are analyzed to identify their components. Component analysis was conducted using an FT-IR (Fourier transform infrared) spectrometer, the appearance was photographed using a microscope, and the thickness was measured with calipers. For the Thailand survey results, only the component analysis was conducted.

Figures 11,12 Analysis of components using FT-IR

In terms of the process of identifying components by reading the solid spectrum using FT-IR, we asked for advice from Associate Professor Fukuhara, Tokyo Institute of Technology (analytical chemistry) to ensure the test quality.

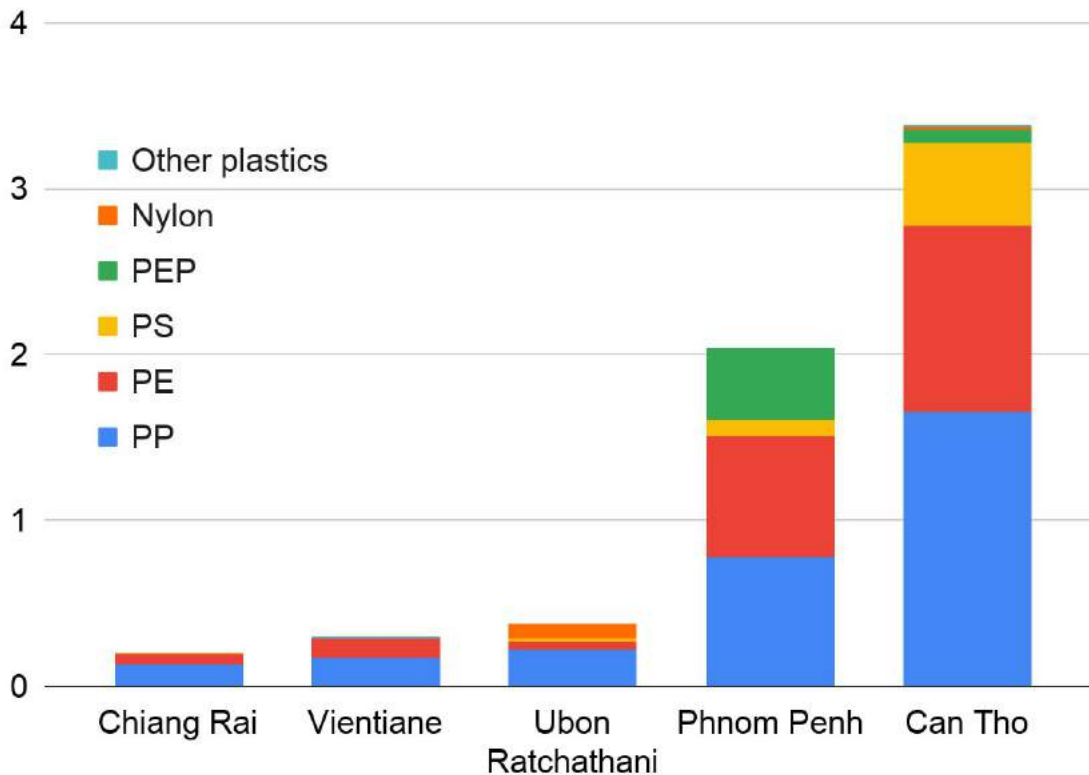
Figure 14 Average Number of microplastics per m³ in rivers

- Plastic fragments were found at 30 out of 33 survey locations. The survey revealed the prevalence of microplastics in the Mekong River basin.
- The most common component in all regions was PP.
- Small amounts of plastic pieces were also found in Chiang Rai, Vientiane and Ubon Ratchathani.
- The amount per volume tended to gradually increase further downstream.
- Since the amount of plastic leakage = flow rate × amount of plastic per volume, we can consider increases to the amount of plastic leakage to be in an even greater range (a river's flow rate generally increases further downstream).
- The increase in values between Ubon Ratchathani and Phnom Penh, and between Phnom Penh and Can Tho were remarkable. It is highly likely that there are large plastic leakages between each city.

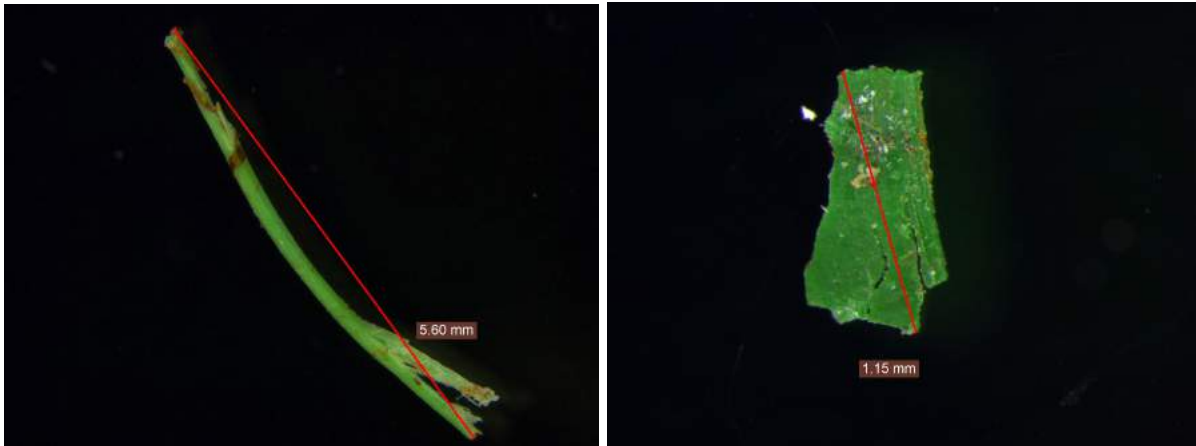
10.7% of the total collection was identified as having a high probability of originating from artificial turf (green color, made of either PE, PP or PEP).

Figures 15,16 Plastic pieces that are likely to be from artificial turf

Debris from artificial turf was found in both the Mekong River basin and Japan. The percentage was 10.7% in the Mekong River and a slightly higher 14.3% in Japan. The difference could be considered to be within the margin of error taking into account the insufficient sample size of the Mekong River basin.

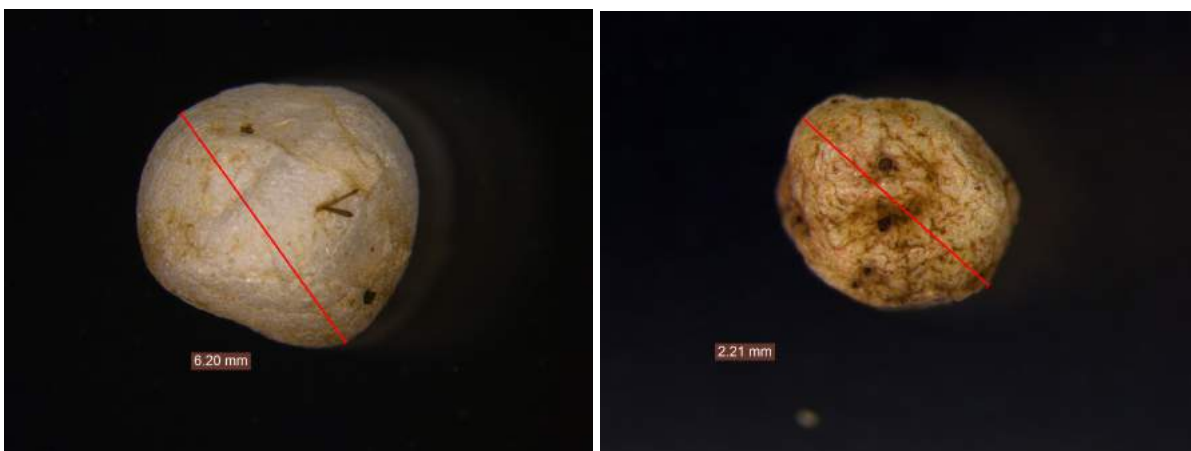
Often used for food trays and containers, Styrofoam (white, elastic and made of PS) was also found and accounted for 8.6% of the total. With its high density making it sink to the bottom of the water, PS was considered unlikely to show up with the method used for this study of collecting from the water's surface. It is conceivable that these pieces were able to float due to a lower density caused by the foaming of plastic.

Figures 17,18 Plastic pieces that are highly likely to be styrofoam

The percentage of styrofoam varied greatly: 8.6% in the Mekong River basin and 0.9% in Japan. Possible causes for the disparity include differences in consumption amount itself and a higher risk of leakage due to differences in the process of styrofoam consumption, collection and disposal.

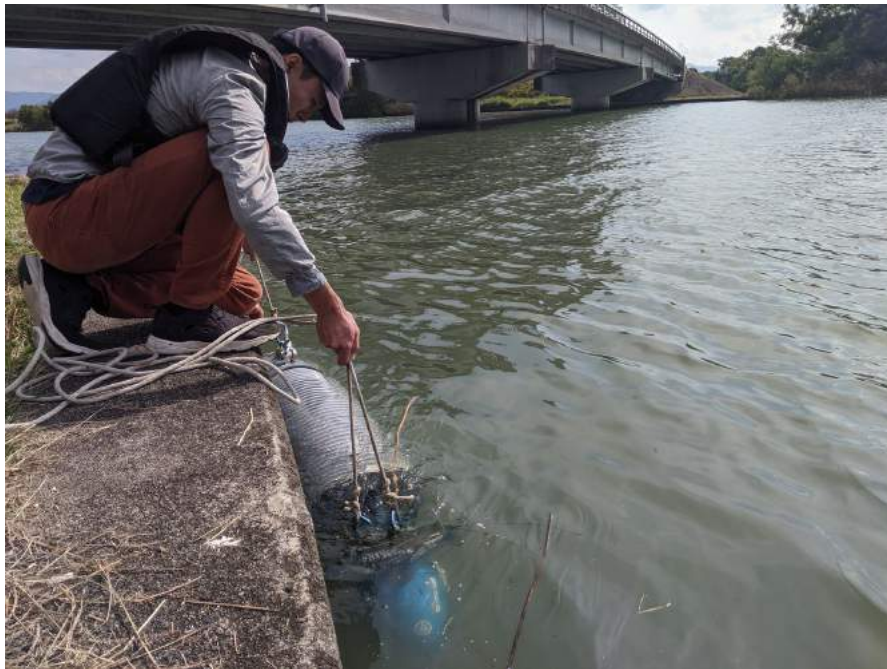
Figure 22 Collecting solids with the device (Albatross Mark VI)

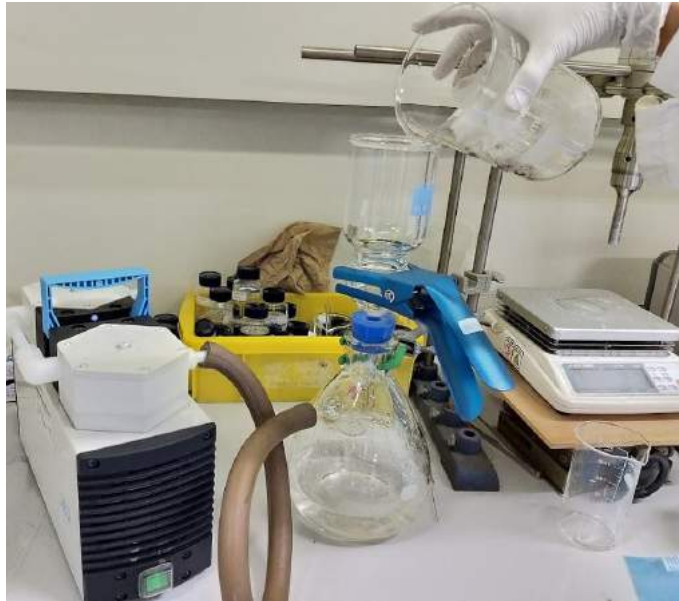
In addition to extraction by visual inspection, some samples were extracted by hydrochloric acid treatment and filtration.

Extraction by hydrochloric acid treatment and filtration is more effective at extracting plastics but has the particularity of requiring chemicals and waste liquid treatment.

Figure 23 Extracting by hydrochloric acid treatment and filtration

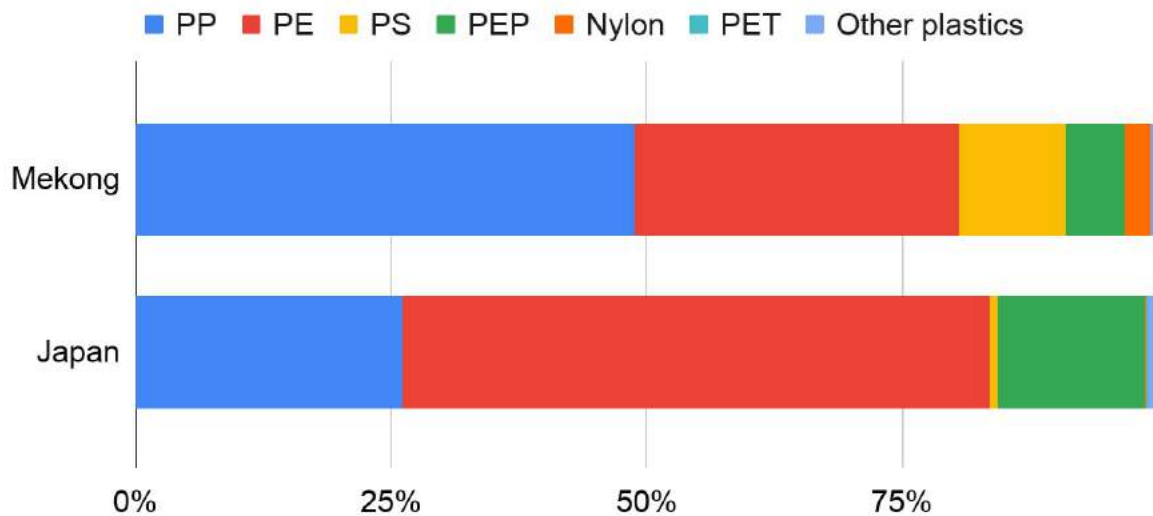
A big difference was observed in the proportion of plastic components. In the Mekong River, PP recorded the largest amount per volume and PE was second. The opposite was true in Japan where PE came first, followed by PP. PP and PE are relatively similar in nature, and some products such as artificial turf could be made with either PP or PE materials. Therefore, the different components of collected plastic pieces may reflect regional differences in the use and proportion of plastic materials.

39.3% of the PP collected in this survey project were red-colored debris that could have been mixed in from the sample collecting device. If we set the assumption that all of these were from the sample collecting device, then there would be an approximately comparable percentage of PP and PE among the microplastics collected from the Mekong River.

Figure 24 Comparison in component types

However, the conclusion that the Mekong River basin has a higher percentage of PP compared to Japan remains for the following reasons:

- PP was also used for the sample collecting device used in Japan.
- Japan's results clearly show more PE than PP.

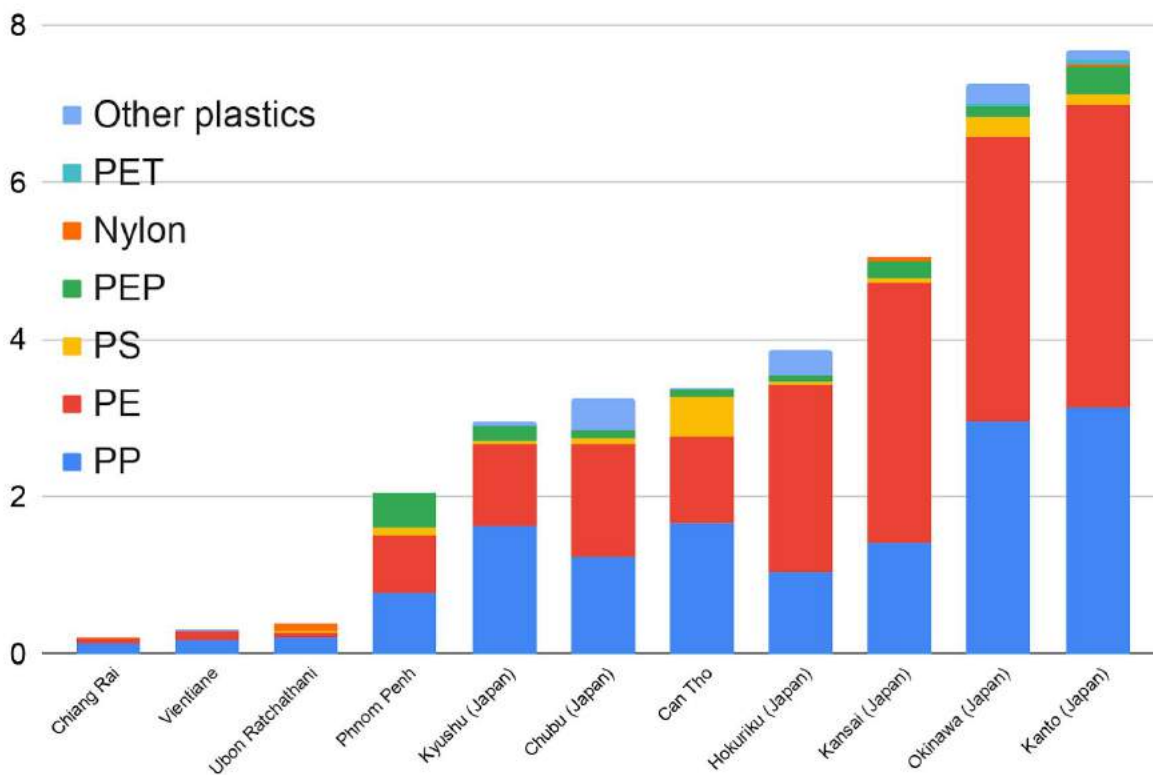
Plastic quantity per water volume for the Mekong River basin and each region of Japan were compared (Japan's values include results from lakes).

Figure 25 Average Number of microplastics per m³ in rivers

The microplastic quantity per water volume in the Mekong River basin was comparatively smaller than in each of the Japanese regions. However, it is difficult to rigorously compare results achieved with different extraction methods and water samplings, as was the case here, as microplastic quantity per water volume can vary depending on the survey method.

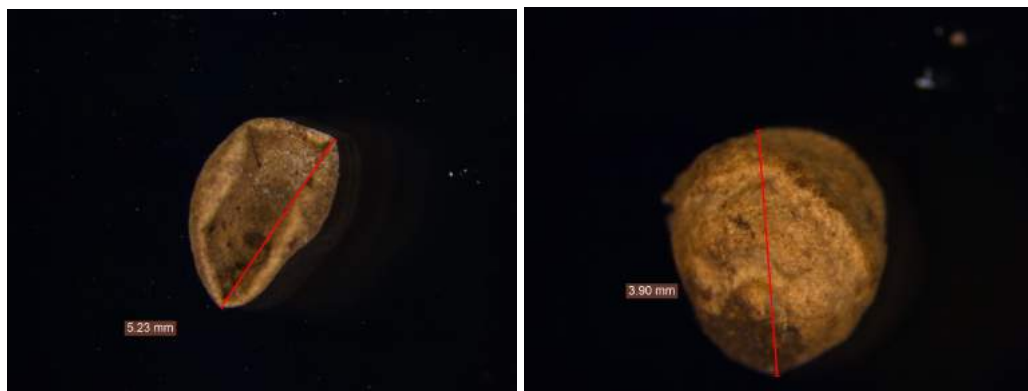
No plastic-coated fertilizers (used in rice fields in Japan and 1.4% of the microplastics found in Japan) were found in this Mekong River basin survey. Variations in rice species, production methods, and fertilizer types may be influencing the result.

Figure 26,27 Plastic coated fertilizer found in Japan
